BUSH'S CHICKEN!
 BLANCO & BITTERS
 SAN ANTONIO, TX. 78230

Project No. 15-054
 Drawn: RJS
 Chkd: RJF
 Date: 11/20/2015
 Drawing

M4.0

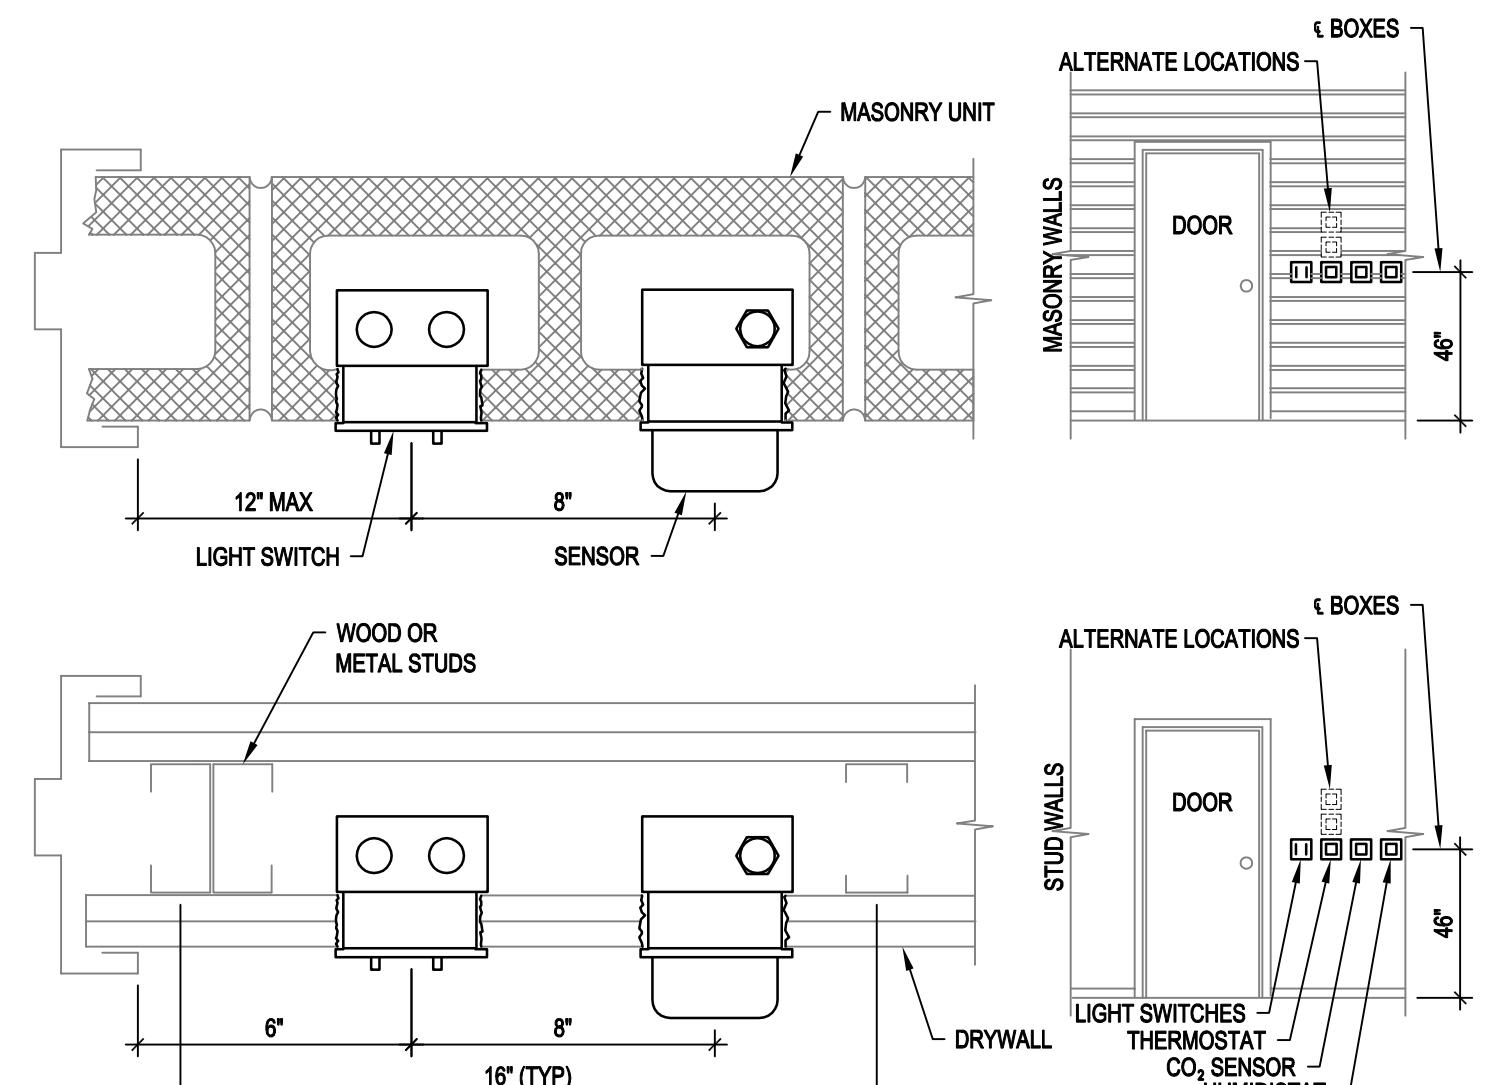
1 ROOM SENSOR OR THERMOSTAT
 DETAIL (NOT TO SCALE)

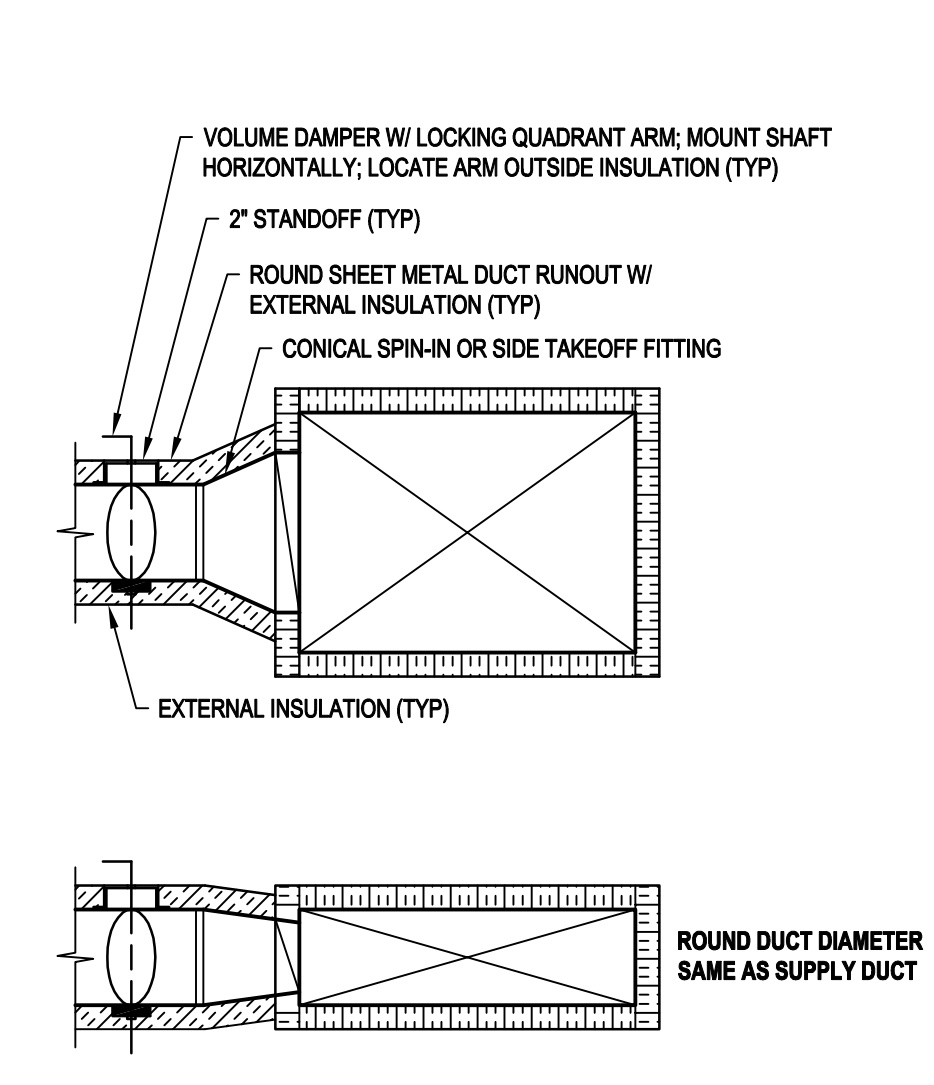
3 TAP CONNECTION
 DETAIL (NOT TO SCALE)

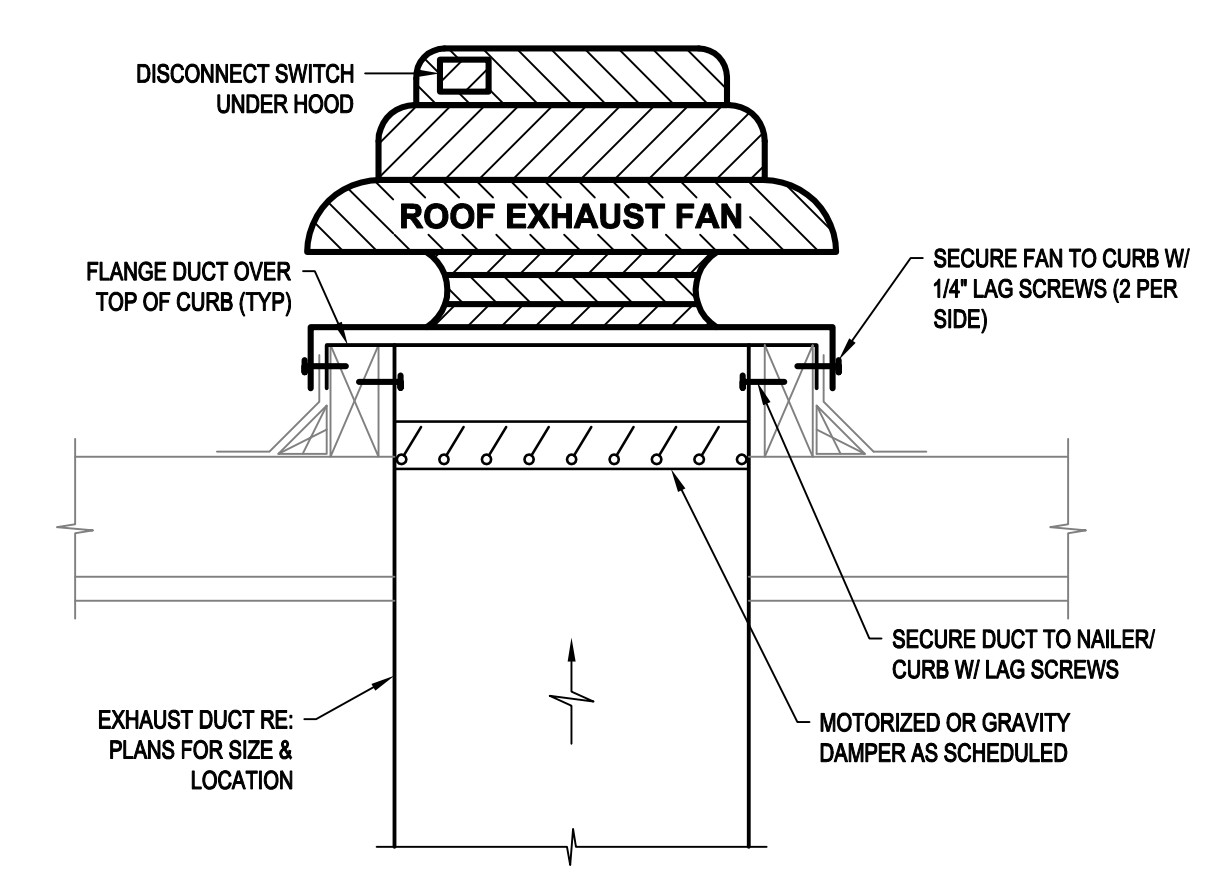
8 ROOF MOUNTED EXHAUST FAN
 DETAIL (NOT TO SCALE)
